MAYNE ISLAND

Land Owners Coalition

Watershed Analysis

RE: Mayne Island, Fish Presence Assessment, July 2010.

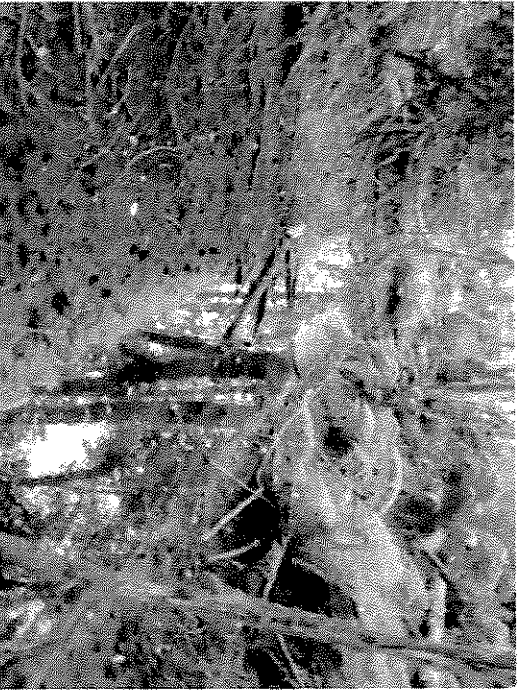
1.) Reach 1 at Tidal area below road (note gravel) Jul/10

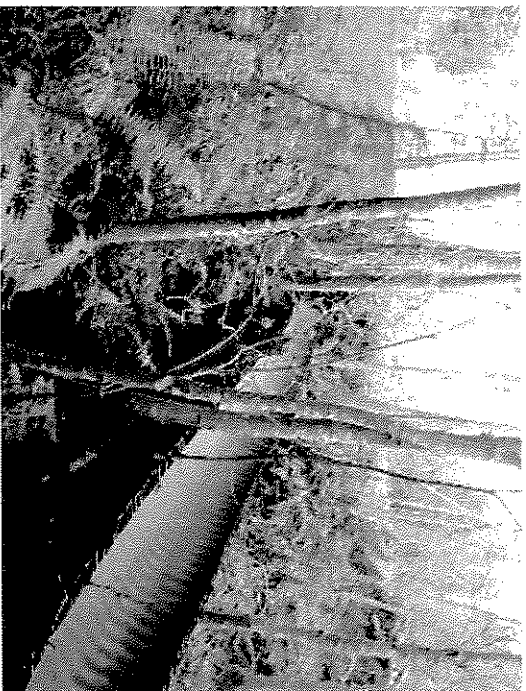
2.) Poor but accessible habitat above Horton Bay Rd culvert.

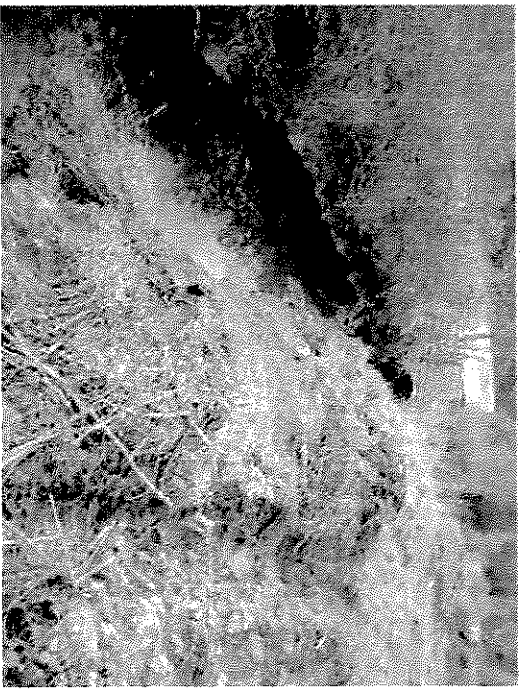
3.) End Reach 1 at Dam, 100m above Horton Bay Rd
End fish access.

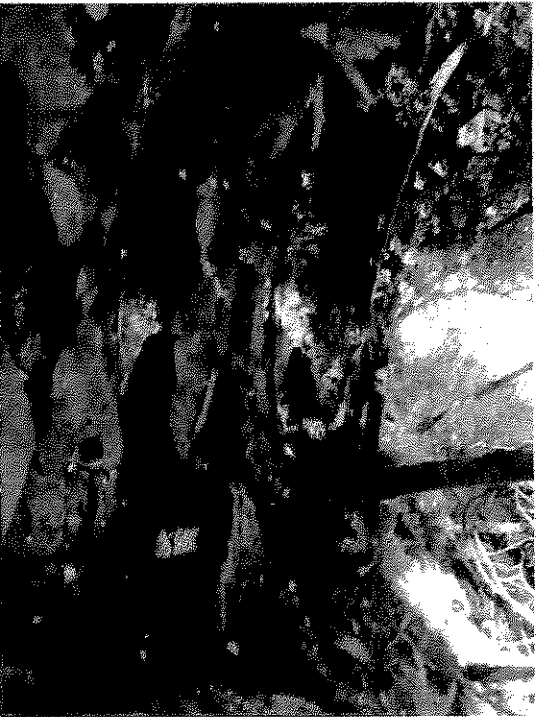
4.) Reach 2 mainstem in April 2008 before going dry.
No fish access/presence.

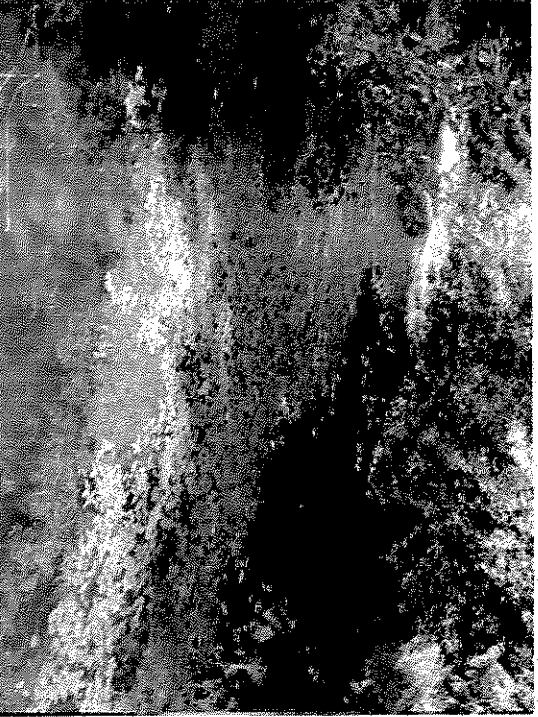
Reach 1: This drainage enters Campbell Bay at a fish barrier above the high tide mark. The first barrier is a 10m long bedrock chute on 24% gradient. A second barrier is located 50m above the ocean on a 9m long boulder cascade at 45% gradient. It is located on a fill slope created for a road crossing and berm for water retention pools on the upstream side. Between these barriers there is a short bench of 5% gradient with bedrock and boulder dominated substrate. On the day of the survey the channel had a minimal flow (approximately 3-lpm) indicating there is no flow later in the summer. This reach was electroshocked along all available wetted habitat with no fish being captured or observed. The first

barrier is a natural barrier; the second barrier appears as man-made rock berm on a native slope of similar gradient. There is no fish access in this reach, nor habitat to sustain resident fish.

1.) Looking upstream at fish barrier located at mouth

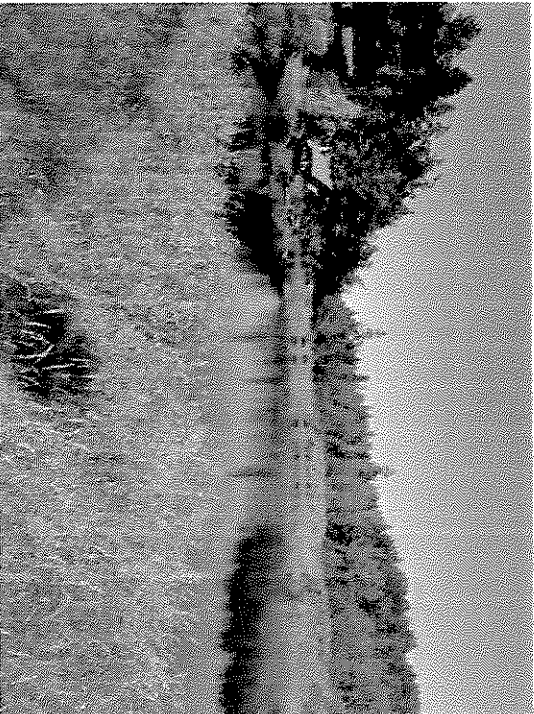
2.) Reach 3 pond adjacent pasture

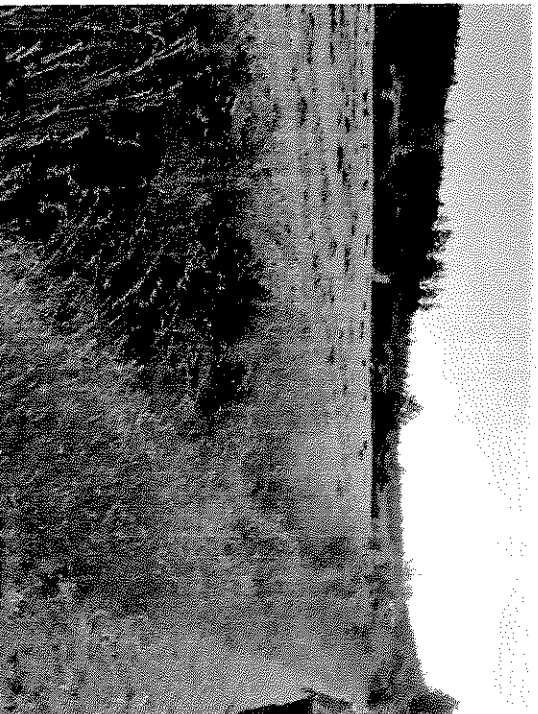
McDougall's pond (#4) is a man-made irrigation pond and the largest body of water in the watershed. It is 130m long and 40m wide with an approximate area of 0.3ha. The mean depth is 3m. This water impoundment has been historically stocked with rainbow trout, the last time approximately 16 years ago. Since that time the trout have died and no further stocking has been undertaken and no fish observed³. The pond was surveyed for fish presence with 12 baited minnow traps placed around the perimeter and middle of the pond at depths ranging from 1-3m. No fish were captured but numerous red legged and tree frog tadpoles were collected.

3.) McDougall's pond reach 3

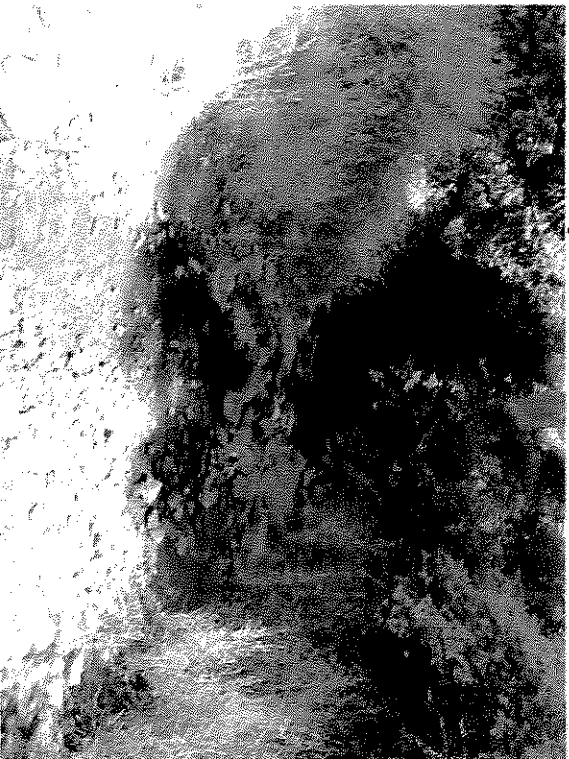
Reach 4: This reach runs for approximately 1,150m from McDougall's Pond upstream through a pastured ditch to Fernhill Road. This reach featured a dense canopy of Nootka Rose, Crab Apple and grasses. The channel ran on a mean gradient of 4% and had a substrate of clay and organics. This reach has seasonal flow as indicated by the completely vegetated substrates. This reach was dry on the day of the survey and is inhospitable to fish. The channel was not surveyed above Fernhill Road given the lack of water presence.

4.) Reach 4 typical habitat within farm pasture

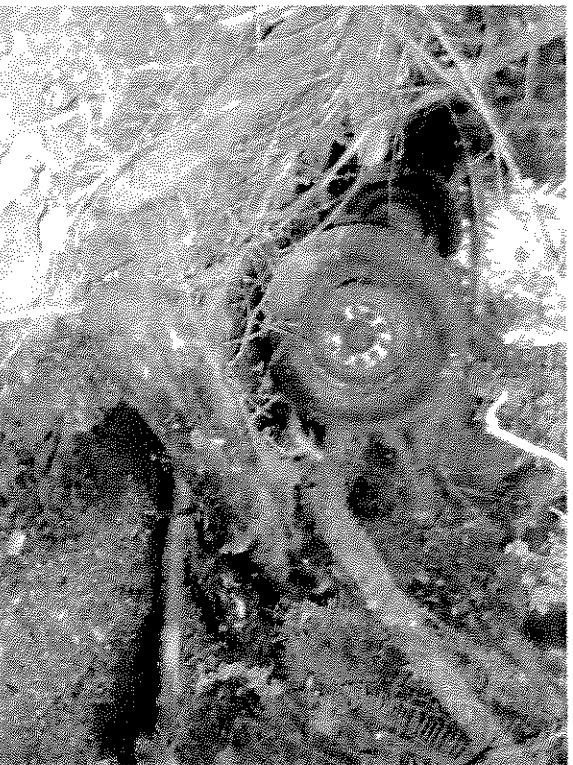
1.) Reach 1 Creek mouth near Village Bay

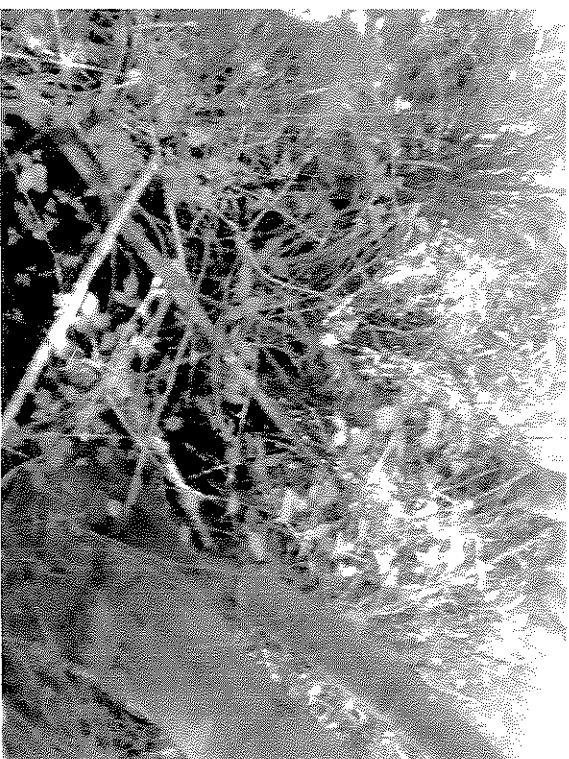
2.) Reach 2 above Dakon Road (debris jam)

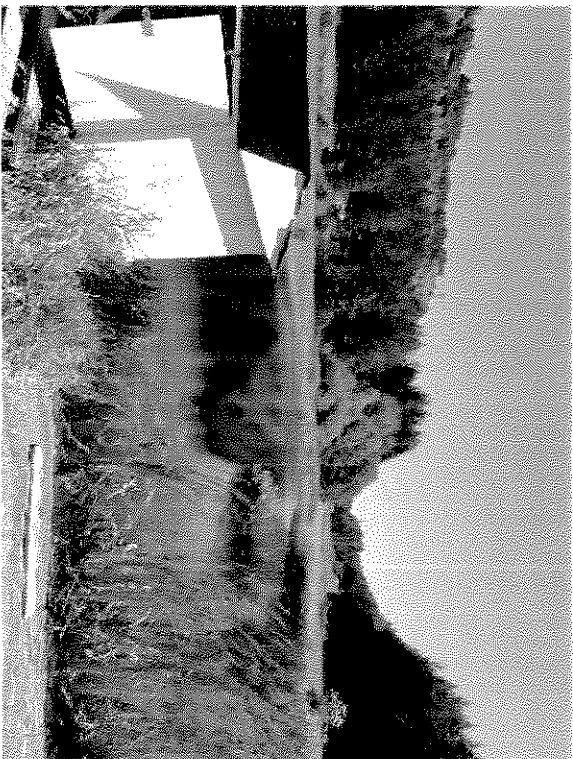
3.) Reach 2 fish barrier along Merryman Road
