## **Mayne Island Fish Presence Survey – Salmon Spawner Survey 2011**

## **RE: Mayne Island, Fish Presence Assessment, December 2011.**

**DR Clough Consulting Photo Page  
Mayne Island Fish Presence Report  
Winter 2011 Page 1 of 2 Deacon Creek**

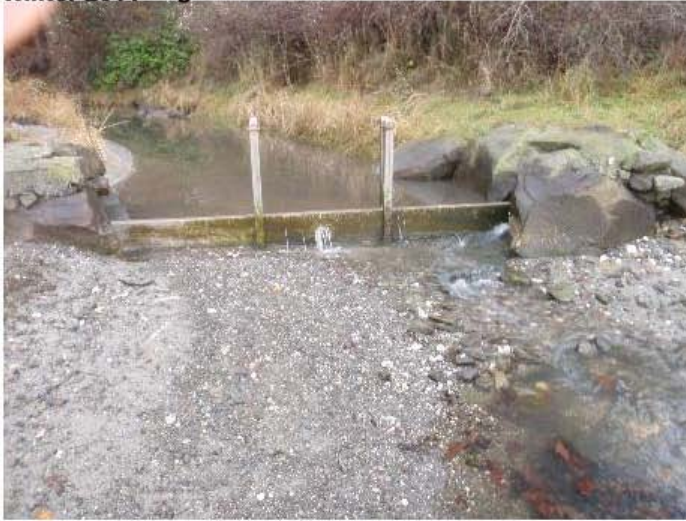
**1.) Deacon Creek weir at intertidal boundary**

**Reach 1:** This reach is 140 m long and extends from the Village Bay beach upstream past houses and yards to Dalton Road Culvert. The intertidal area was inspected for evidence of beach spawning chum or any carcasses. At the mouth was a flock of sea gulls but no evidence of fish. A 30cm high concrete weir crosses the creek mouth. The next 30m offers no barriers to fish on a moderate 3% average gradient. At the property boundaries of #533, 535, and 525 Dalton Road, each owner has anchored 3" seine nets or page wire in the streambed to prevent deer access. Although unintentional these deer fences would completely block upstream access for any potential salmon spawners. This reach appeared to have degraded and eroded even further since the July survey.

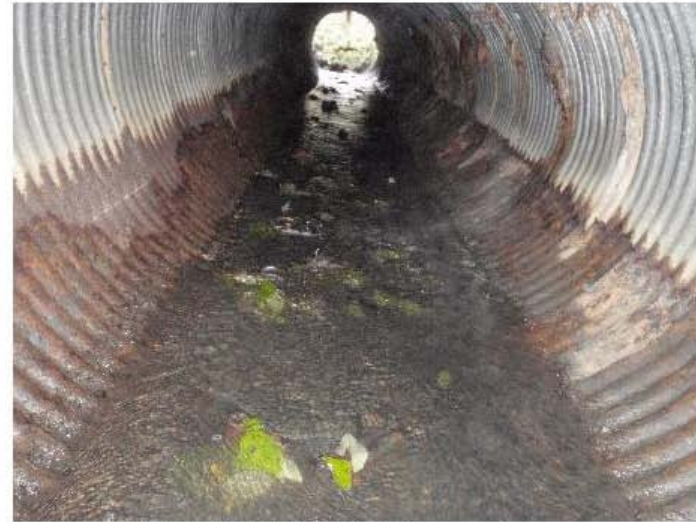
**3.) Culvert below Village Bay Road**

**Reach 2:** The channel crosses Dalton Road through a 1500mm metal culvert, which was sealed with a page wire fence on the downstream side. The best substrates for spawning were located within the culvert itself. These substrates of 2-4" gravels which appeared relatively stable and devoid of compacted fines. Above Dalton Road the stream had less than 1% of usable substrates for spawning, while the remainder was organic material and fine clays and sands. There was no evidence of spawner activity on the available gravel in the culvert or otherwise. Due to the numerous barriers, Reach 2 was inaccessible to fish.

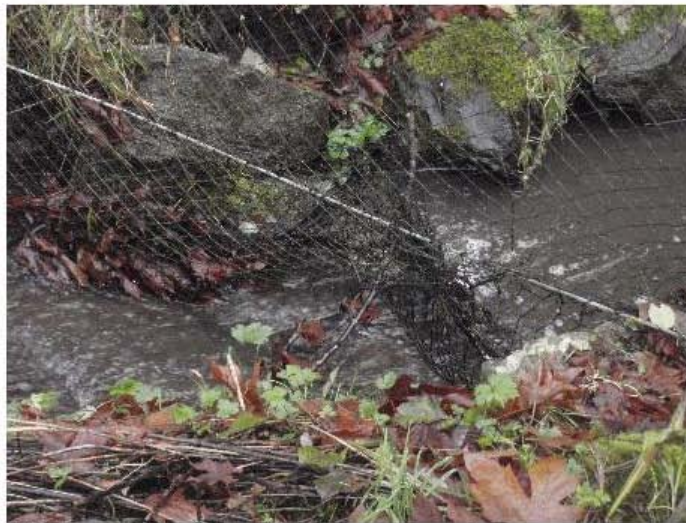
**2.) Seine net fence at 535 property boundary**

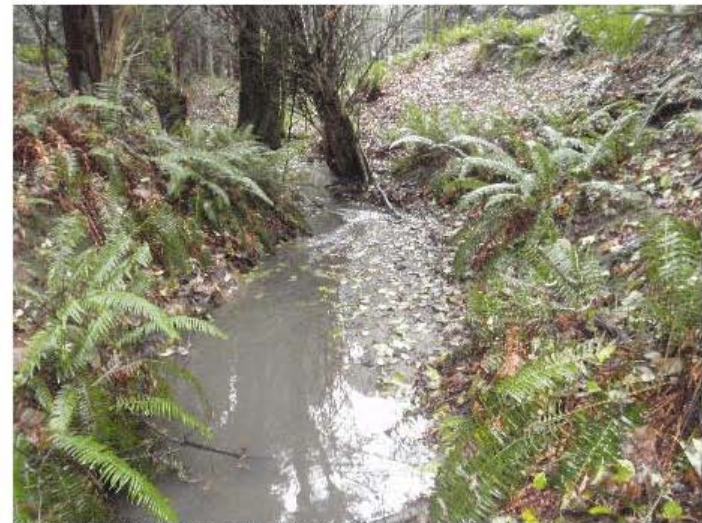
**4.) Reach 2: Typical Habitat above Village Bay Road**

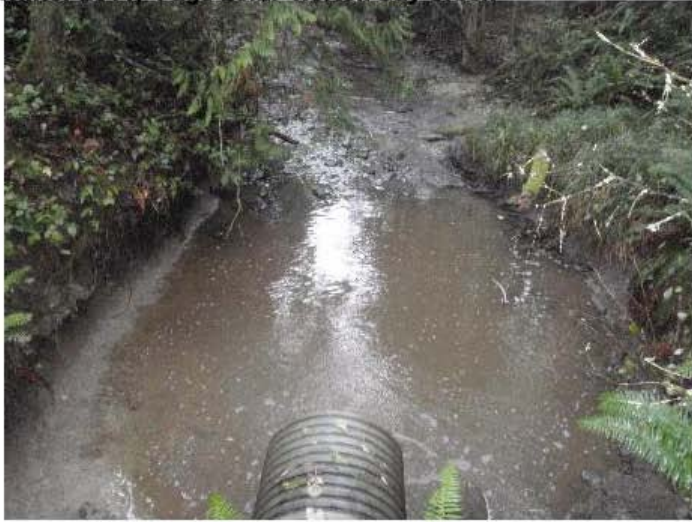
**1.) Looking downstream off Horton Bay Road**

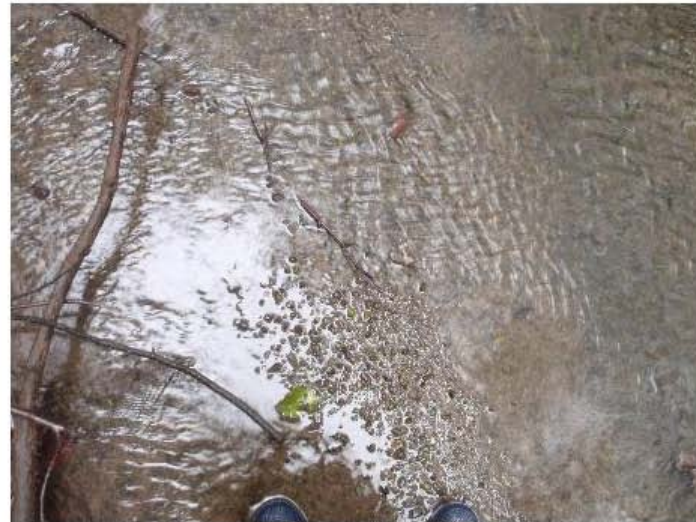
**3.) Typical substrates in the lowest reach**

The lower reach is approximately 150m long. There is a long confined muddy estuary leading to the creek mouth at the road culvert. The substrates were mixed gravel and sand that was compacted and embedded with no upwelling percolation evident. The survey began at low tide allowing inspection of the estuary substrates for activity. There were no observations of fish presence nor any redds apparent. The stream had approximately 10cm of water depth within the shallow channel. Potential fish access continued above the culvert another 100m on a shallow clay covered glide. No spawning gravel or redds were observed. Each side of the shallow forested riparian area was walked looking for carcasses but none were observed. The reach ends at the fish barrier which is a dam and spill pipe on a natural rise in the land at 130m upstream of the Horton Bay Road

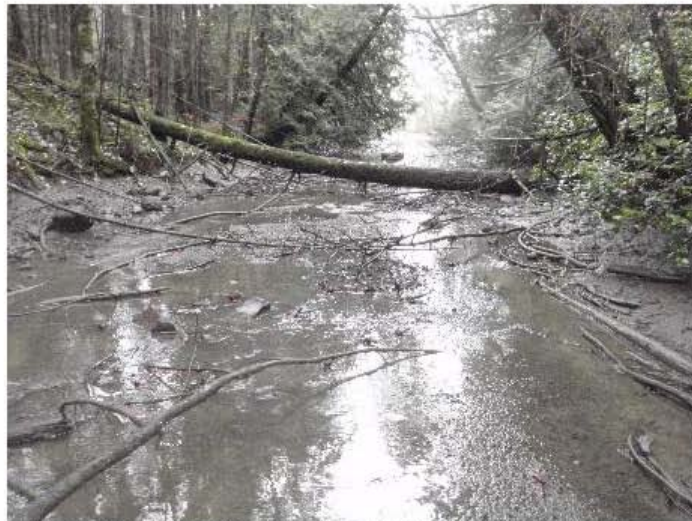
**2.) Looking downstream below Horton Bay Road**

No salmon carcasses or redds were observed during this survey. The only potential spawning gravel was located below the Horton Bay Road culvert, in the intertidal area but these gravels were impacted with fines with no evidence of use.

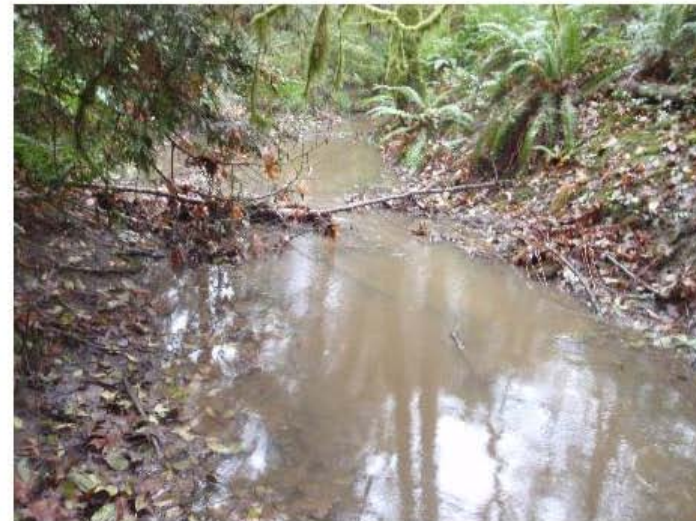
**4.) Typical habitat above Horton Bay Road**
