D. R. Clough Consulting

Mayne Island Land Owners Coalition

Mayne Island Fish Presence Survey – Salmon Spawner Survey 2011

RE: Mayne Island, Fish Presence Assessment, December 2011.

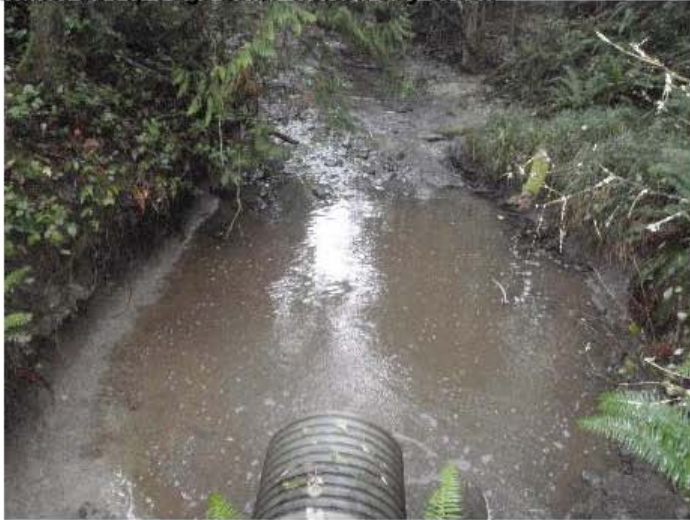
1.) Looking downstream off Horton Bay Road

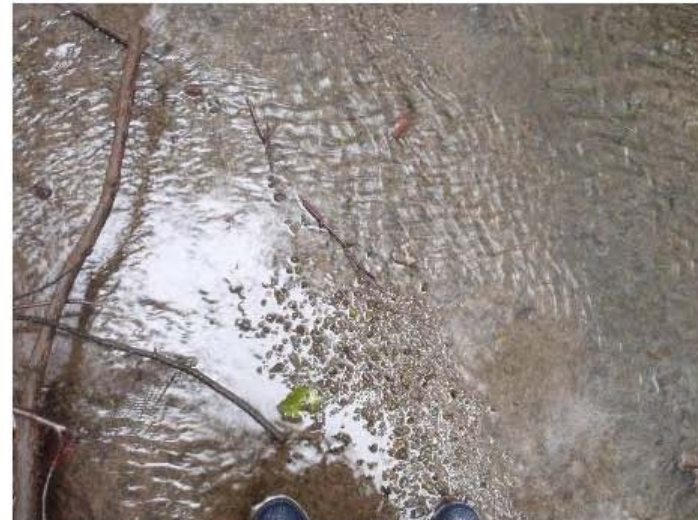
3.) Typical substrates in the lowest reach

The lower reach is approximately 150m long. There is a long confined muddy estuary leading to the creek mouth at the road culvert. The substrates were mixed gravel and sand that was compacted and embedded with no upwelling percolation evident. The survey began at low tide allowing inspection of the estuary substrates for activity. There were no observations of fish presence nor any redds apparent. The stream had approximately 10cm of water depth within the shallow channel. Potential fish access continued above the culvert another 100m on a shallow clay covered glide. No spawning gravel or redds were observed. Each side of the shallow forested riparian area was walked looking for carcasses but none were observed. The reach ends at the fish barrier which is a dam and spill pipe on a natural rise in the land at 130m upstream of the Horton Bay Road

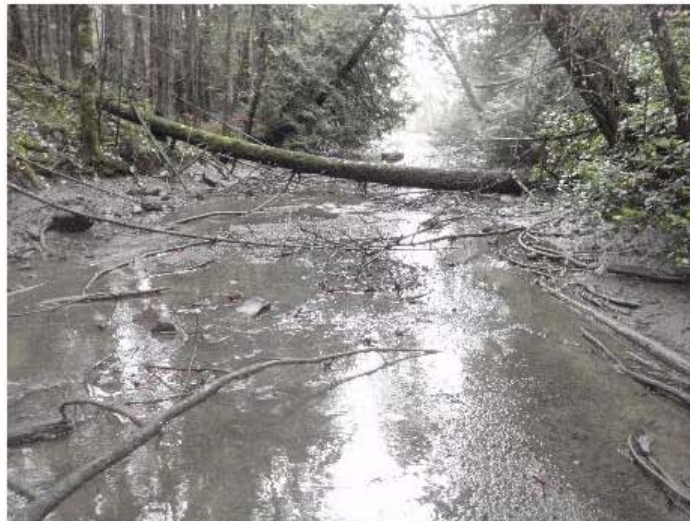
2.) Looking downstream below Horton Bay Road

No salmon carcasses or redds were observed during this survey. The only potential spawning gravel was located below the Horton Bay Road culvert, in the intertidal area but these gravels were impacted with fines with no evidence of use.

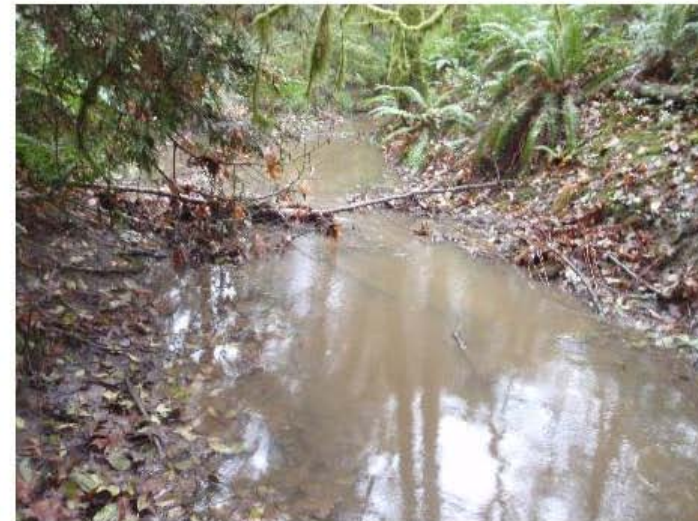
4.) Typical habitat above Horton Bay Road
