MAYNE ISLAND

Land Owners Coalition

Watershed Analysis

RE: Mayne Island, Fish Presence Assessment, July 2010.

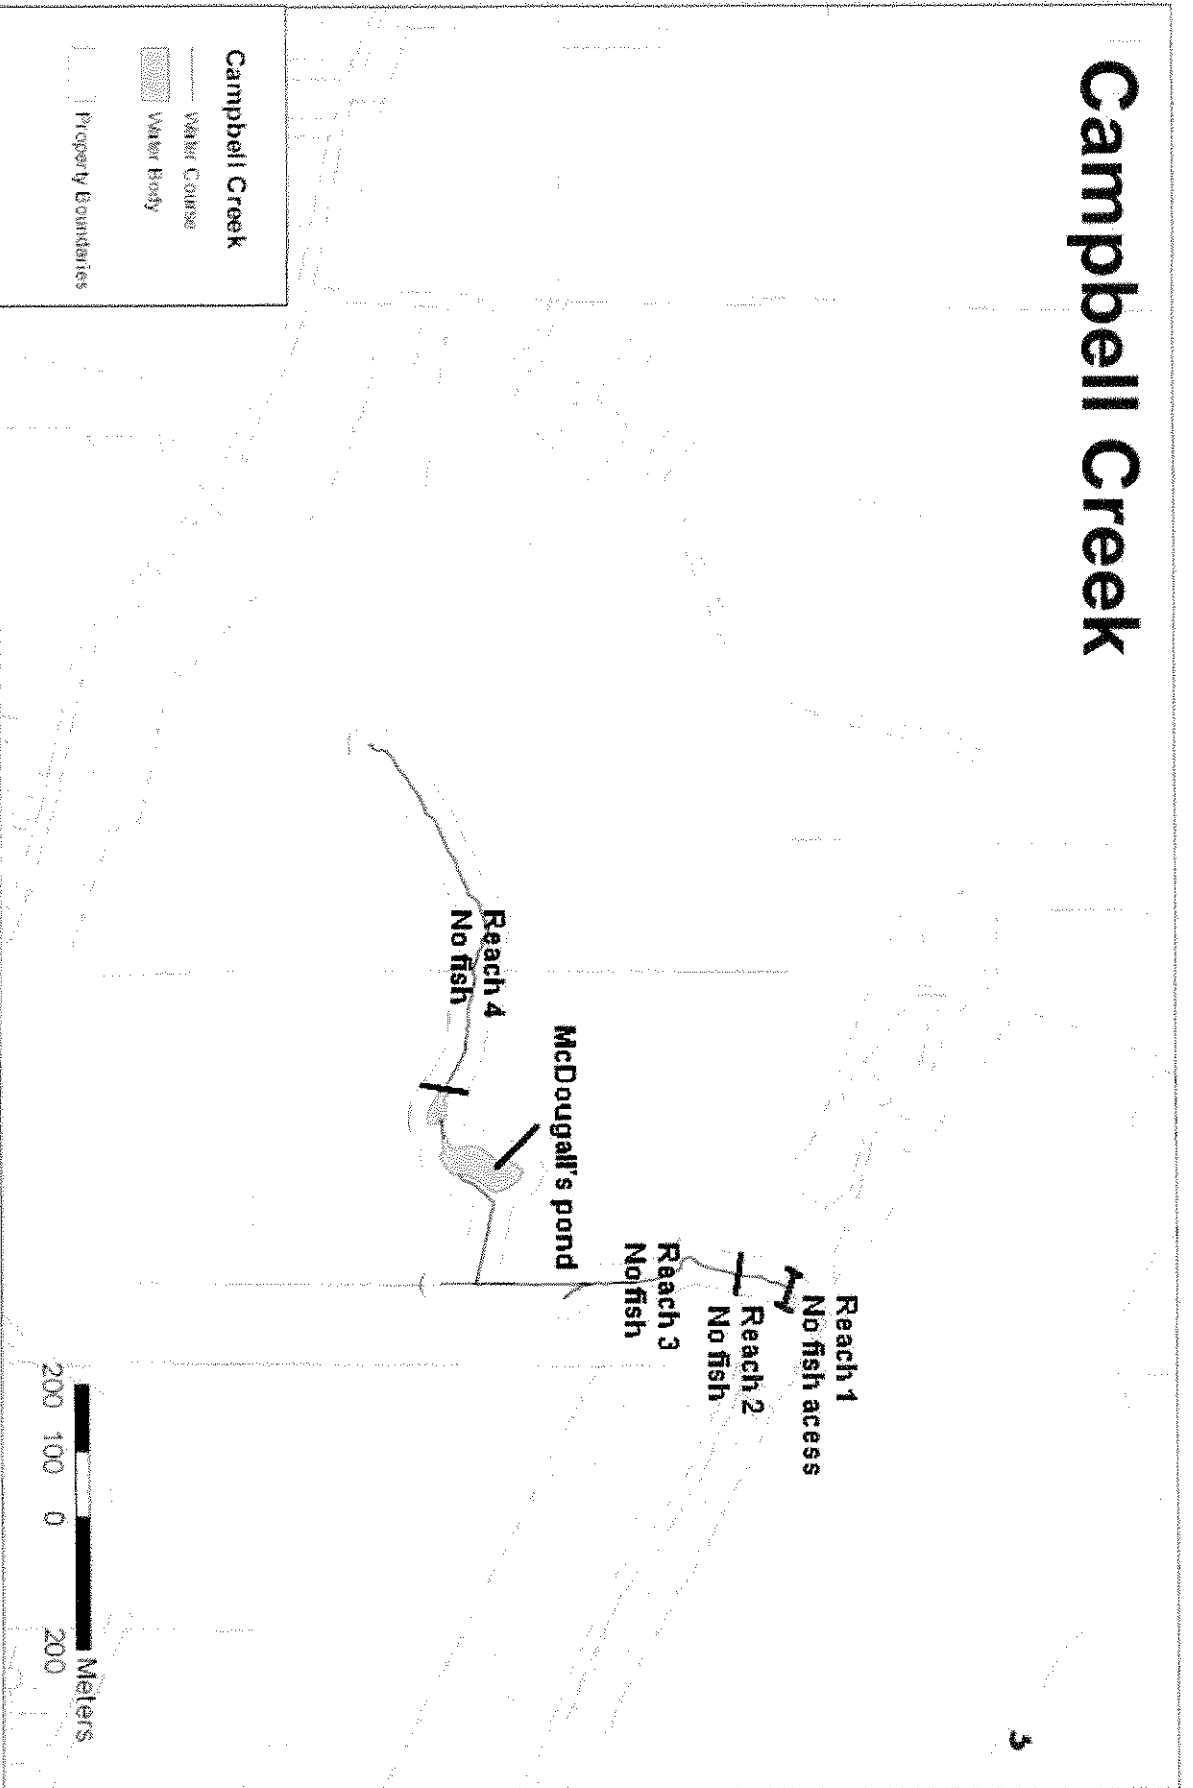
Campbell Creek Summary: There are no fish present in the watershed. This channel has a series of barriers located directly at the mouth, which offers no fish access. The entire wetted area of the upper reach of this watershed was electroshocked with no fish captured. The main pond, once stocked with Rainbow Trout was minnow trapped with no fish being captured or observed. Water quality samples throughout indicate it is or becomes intolerable to fish due to drying, high temperatures, anoxia or a combination there of.

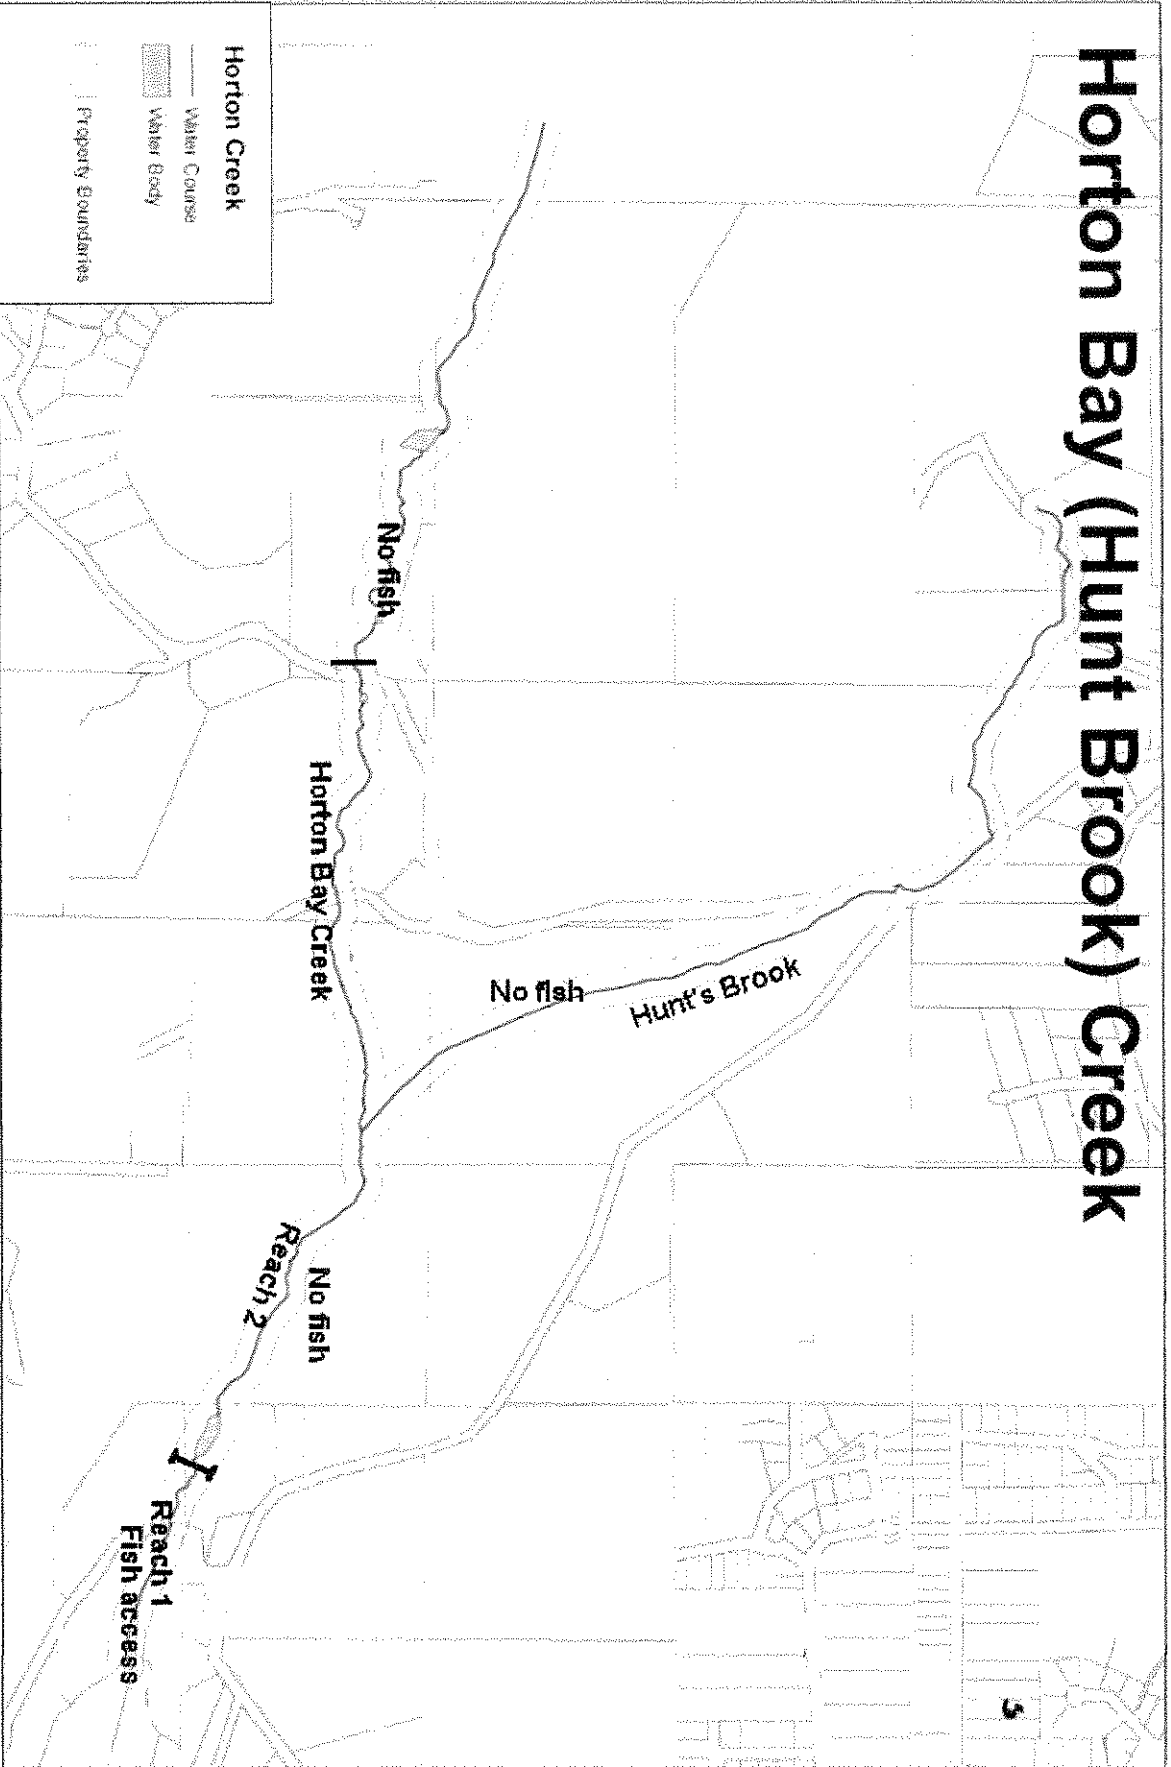
Horton Bay (Hunt Brook) Creek

There were no fish observed or captured in the entire length of stream. Its lower reach, which has potential fish access, has never revealed any fish use in the three inspections in the last three years. Our 2008 fisheries assessment report had the same result. The tidal reach lacks sufficient fresh water and suitable substrate to offer spawning success. Upstream; the dam is a man-made impoundment, it is hard to tell if there is a natural barrier feature it was built upon. Regardless, we have inspected the Reach 2 and 3 on three separate occasions in winter and summer and find the habitat above the dam to not offer any potential for fish populations. It dries to mud or stagnant pools that would kill fish.
